Wildlife-friendly Fence at Middelpunt Wetland

Progress Report

The White-winged Flufftail Conservation Project

Dr Kyle J. Lloyd
April 2023

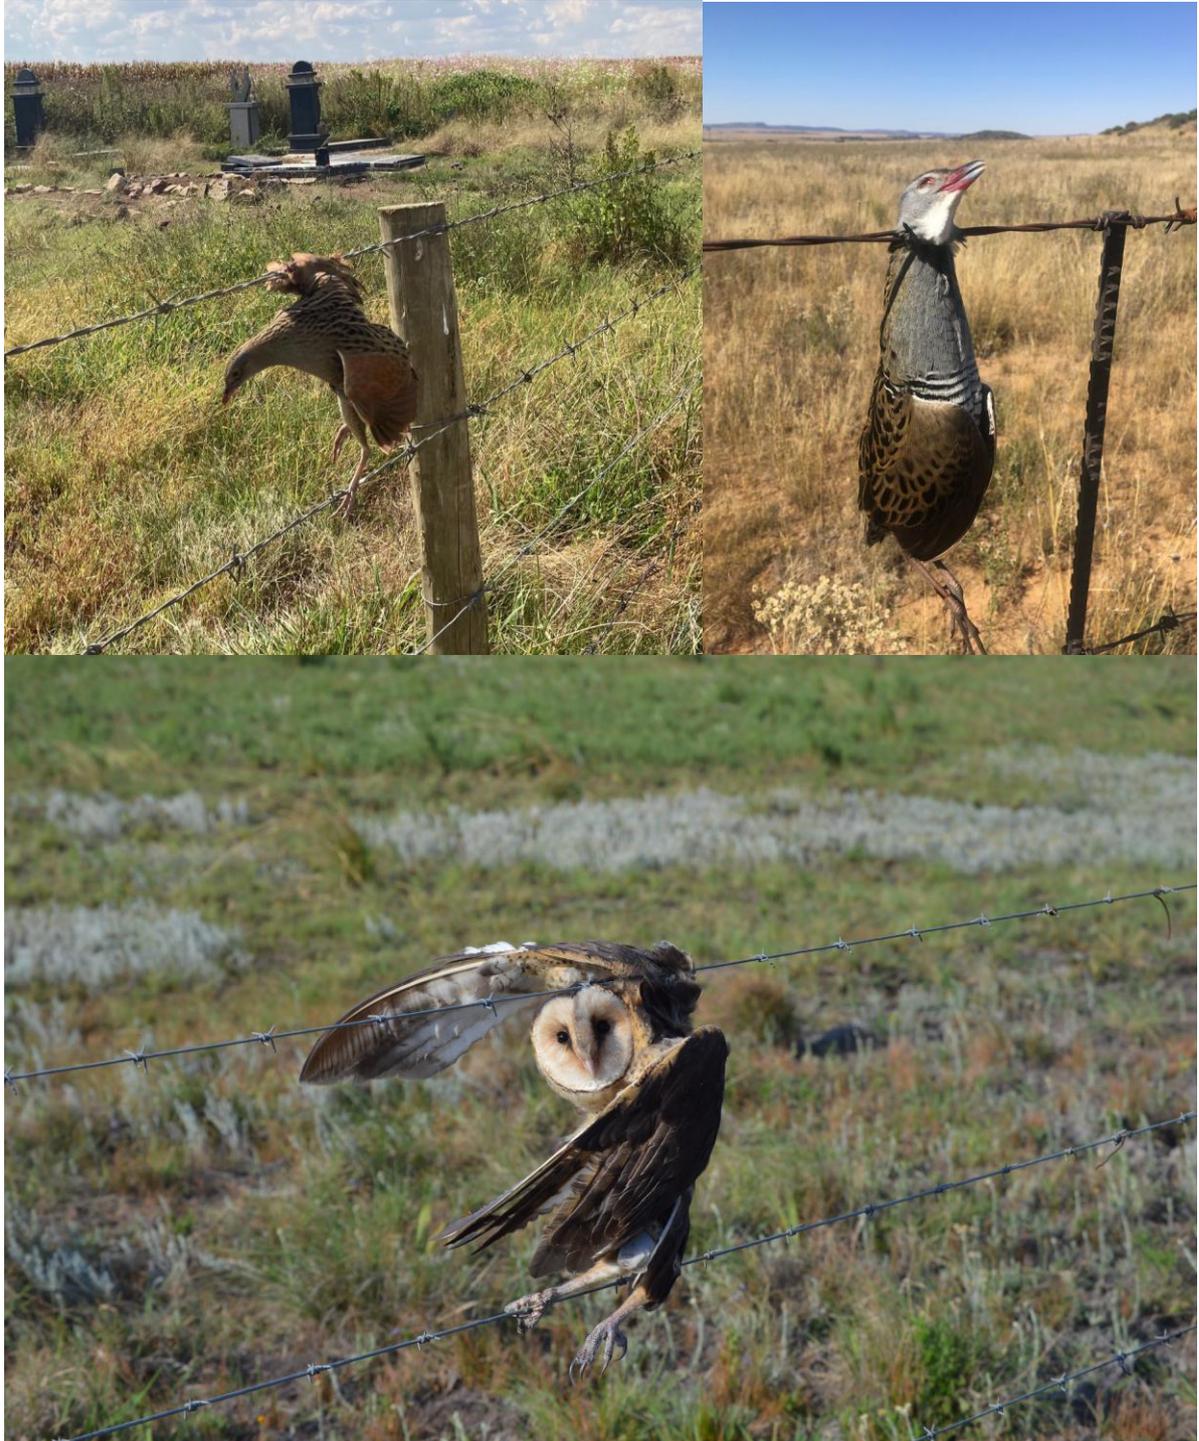
Figure 1: Wetland bird species are common victims of barbed fence entanglements.

Barbed-wire fences pose a risk of injury or fatality through collision and entanglement for wildlife. This often happens along fences intercepting wetlands as animals frequently move between these highly productive ecosystems and the surrounding grassland matrix (Figure 1). To reduce the risk of entanglement and increase permeability for wildlife while still excluding livestock, a wildlife-friendly fence was designed based on literature (namely stemming from the grasslands of the USA) and expert advice from local farmers for adaptation to the South African context. This included a smooth wire 30 cm above the ground followed by three strands of barbed wire and a smooth top strand 30 cm above the barbed wire directly beneath (Figure 2). The height of the smooth bottom strand allows for smaller mammals to move underneath without the risk of snags while excluding cattle and their calves. The distance between the smooth top strand and barbed strand below it should be sufficient to prevent birds from becoming entangled as the two strands loosen over time.

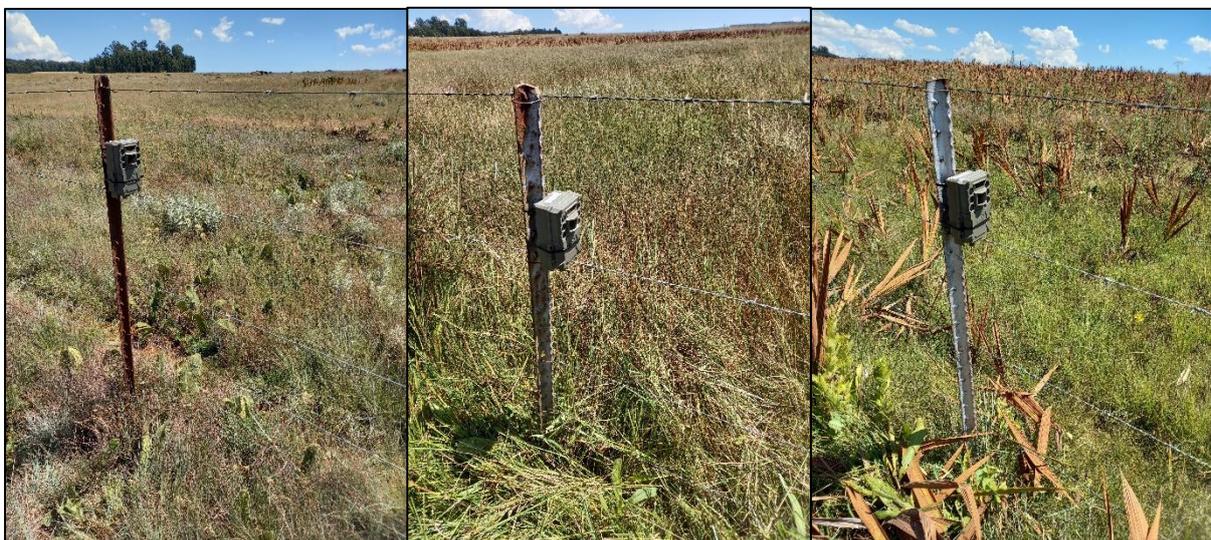
Figure 4: Camera traps placed on the standard cattle fence at Middelpunt Nature Reserve acting as a control for comparison to the wildlife-friendly fence (Photos: Marlize Muller).

A study has been initiated to evaluate the effectiveness of the wildlife-friendly fence in allowing wildlife to move through while reducing risk of entanglement and keeping livestock out. Motion-detected camera traps were used to observe the interactions between animals and the fence. Five cameras were deployed on the wildlife-friendly fence (Figure 5) and five on a standard cattle fence (i.e., the control; Figure 4) running on opposite sides of Middelpunt Wetland in December 2022. The position and perspective of the cameras on the fence posts were determined through a pilot study conducted in August 2022. Cameras were spaced evenly along the fences at approximately 100-200 m intervals. The habitat type of the surrounding vegetation (either seep or grassland) was recorded for each camera. Cameras are serviced every two months to replace batteries, swop SD cards, clear vegetation, and right camera alignment. Preliminary results show that wildlife is interacting with the wildlife-friendly fence with no entanglements observed thus far (Figures 6 & 7). The study will continue for at least one year with the sorting of the camera trap images taking place simultaneously.

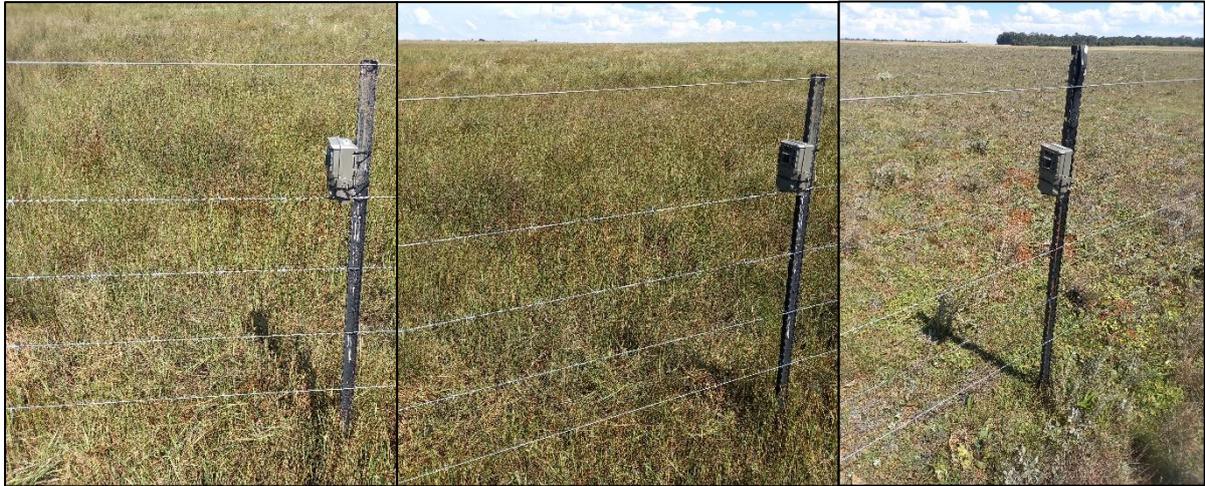
Figure 5: Camera traps placed on the wildlife-friendly fence to monitor animal movement at Middelpunt Nature Reserve (Photos: Marlize Muller).

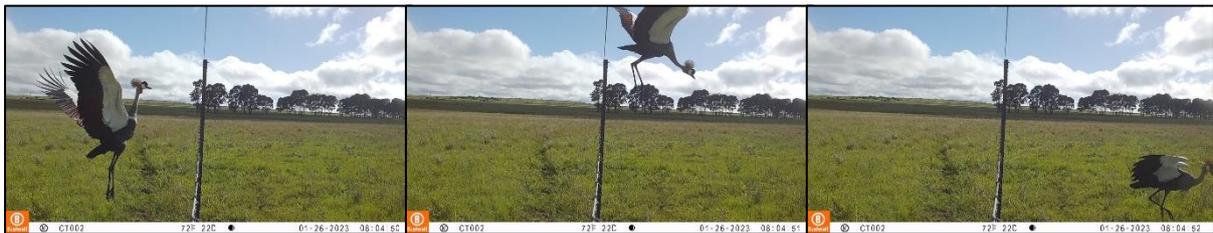
Figure 6: Sequence of images showing a Grey Crowned Crane (*Balearica regulorum*) jumping over the wildlife-friendly fence without difficulty (Photos: Kyle Lloyd).

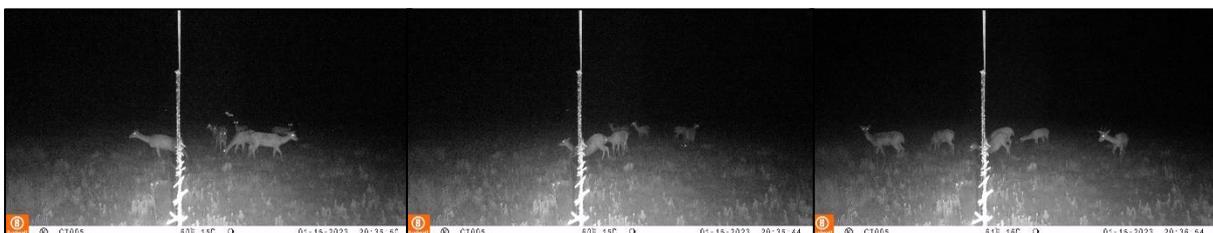
Figure 7: Sequence of images showing antelope passing underneath the wildlife-friendly fence without difficulty (Photos: Kyle Lloyd).
